VALIDATION OF SPOT-5 SATELLITE IMAGERY FOR GEOLOGICAL HAZARD IDENTIFICATION AND RISK ASSESSMENT FOR LANDSLIDES, MUD AND DEBRIS FLOWS IN MATAGALPA, NICARAGUA

ABSTRACT:

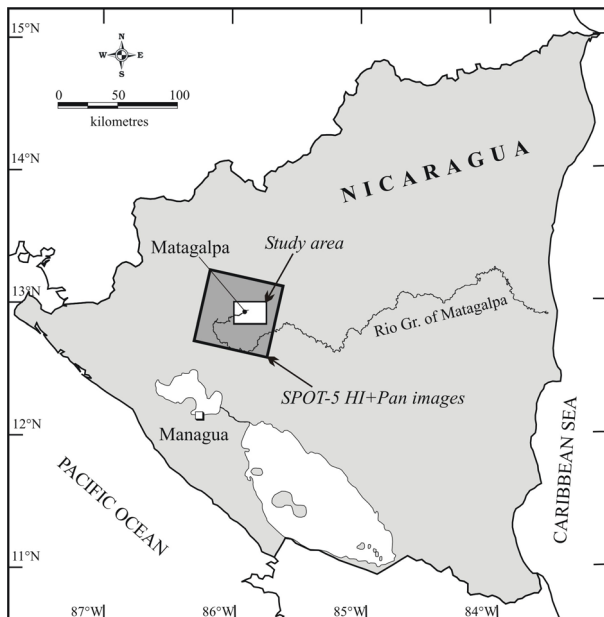
Figure 1. Simplified map of Nicaragua with the location of the SPOT-5 Hi+Pan images. The white frame represents the area of investigation (equal to the Matagalpa INETER 3054-IV topographic sheet).

CNES and Spot Image provided UNOSAT with two 60 x 60-km-wide satellite images centered on Matagalpa (Fig. 1), acquired during the dry season (19 April, 2003), with the following specification:

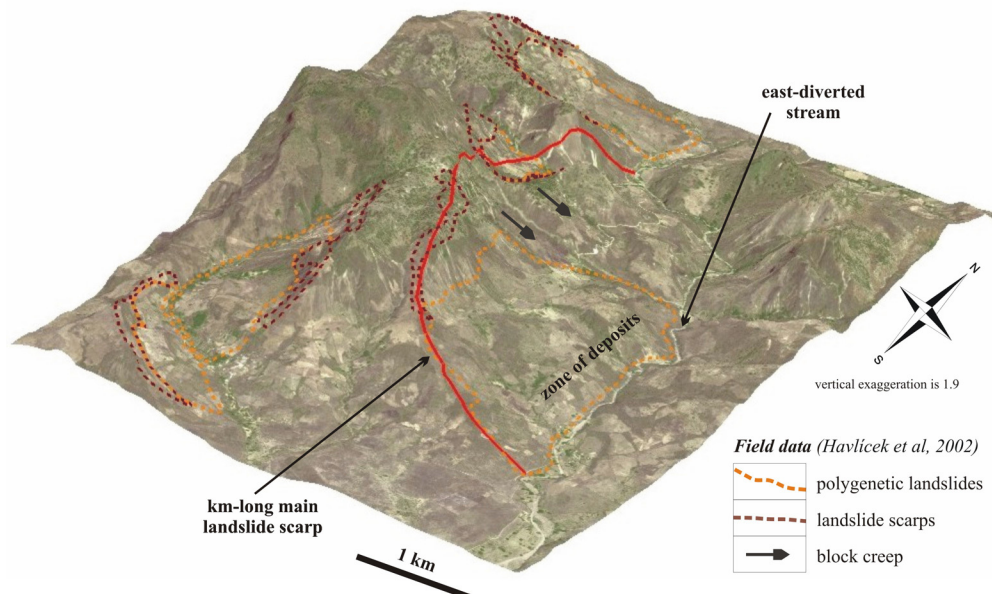
Figure 2. Pseudo-color SPOT-5 image draped over DEM for 3D simulation with the main scarps of large landslides. Typical indicators for landslides are disturbed vegetation and deflection of stream traces at the foot of the zone of deposits. Field data of Havlíček et al. (2002) are reported for comparison.

On a pseudo-color SPOT-5 image draped over a DEM for 3D simulation, several features typical of landslides that have actually taken place were visually recognized: a) spreadings at toe, with river diversion; b) slope ruptures created by scarps; c)

deformation of linear features, like roads (Fig. 2). The 2.5 m pixel resolution appears as a significant improvement of SPOT-4 imagery, allowing a more reliable detection and the tracing of the boundaries of the landslides. Our remote sensing-based map shows a good correlation with the field observations collected by Havlíček et al. (2002). The main difference lies in the fact that large-scale sliding structures, such as kilometer-wide slope instabilities are better evaluated using imagery. Some of the detected landslides are presumably still active, as revealed by low-vegetated parcels or barren soils. This suggests that the SPOT-5 product can be used for qualitatively monitoring the landslide activity, although it is unlikely to determine the nature of the movements occurring, i.e. if they are rotational, translational or multiple. Limited time gap and atmospheric perturbations in our SAR interferometric dataset prevented us from corroborating these land deformations.

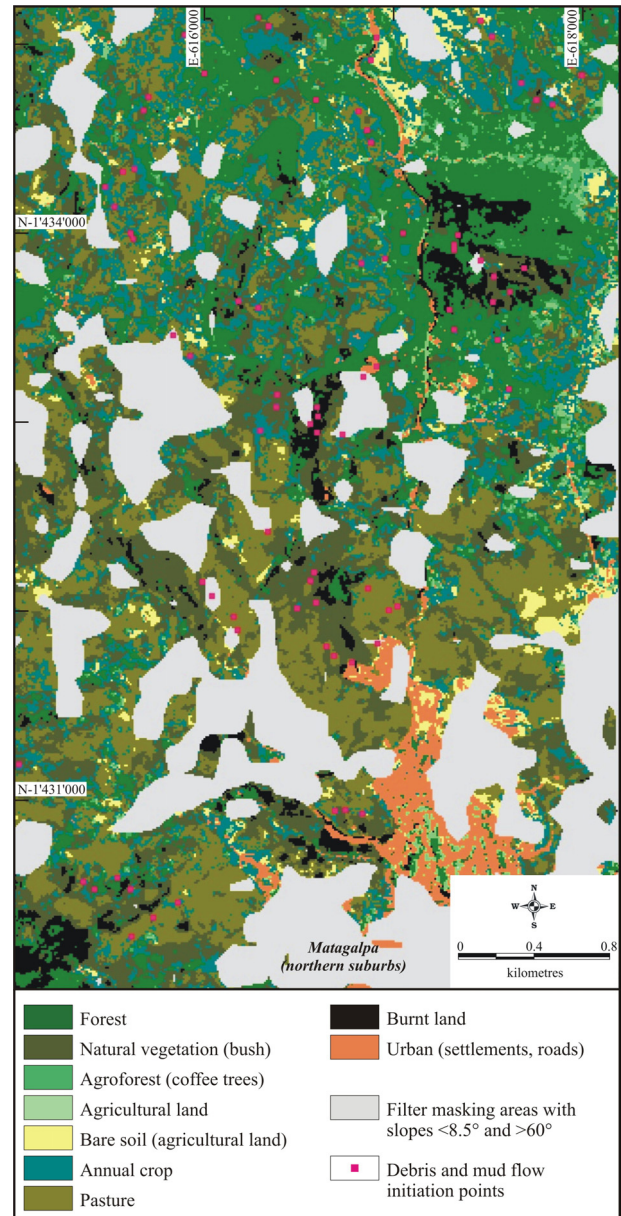
Figure 3. Overlay of the initiation points of 1998-active mud and debris flows (Cannon et al., 2001) on a slope-filtered SPOT-5 land cover map, showing that, north of the city of Matagalpa, annual crop lands and deforested areas (pastures and agricultural lands close to the forest boundaries) are soils with moderate to high predisposition to geohazards.

The input of a pseudo-color SPOT-5 image and derived land cover classifications to hazard susceptibility mapping appears as restricted, since the prime factors controlling the predisposition of soils to landslides, mud and debris flows, such as geology, terrain slope and hydrography are themes hardly retrievable. Knowing that hill slopes are the most important data for susceptibility issues, a DEM from which a classified slope map can be calculated is a pre-requisite product for this procedure. This slope map should be applied to filter out the output of the thematic layers, so that only areas with moderate slopes (e.g., between 8.5 and 60 degrees, Fig. 3) are kept as soil candidates with predisposition to natural hazards.

mud/debris-flow-favorable land cover classes seem to be agricultural and pasture lands at the external boundaries of forests (Fig. 3) - areas apparently recently deforested. This suggests that land use changes are also a SPOT-5-retrievable parameter to take into consideration for susceptibility mapping, especially when multi-temporal images are available.
